Simi Settlers' Amateur Radio Club

## Short Circuit

## Summer Antenna Fun - Joe W6JWP

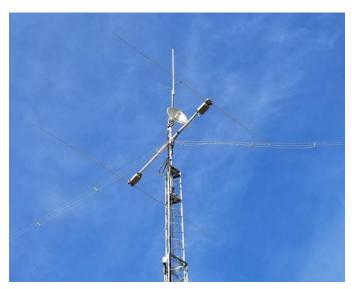
This summer, in addition to my regular antenna and tower maintenance, I decided to replace the N6BT Q52 2 element 5 band compact beam pictured to the right with a Cushcraft A3S 3 element tri-band beam that I had picked up used a few years ago.

I had bought the Q52 back when I was living in Simi Valley and had a very small yard with no room for a tower, so I wanted something that I could put up on my roof. When I moved to Camarillo and a house with a much larger back yard, was able to erect a modest tower (33 foot crank up) with the Q52 at about 36 feet.

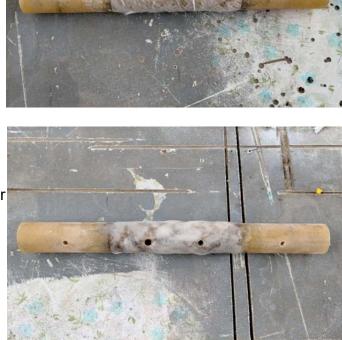
As you can see, the spacer was a hairy mess. I started off by disassembling the driven element for a better look.

After cleaning it up as best I could, it was ready for the next step.

I gave it a day to fully cure then sanded down the rough spots before sealing everything with a UV resistant urethane spray.

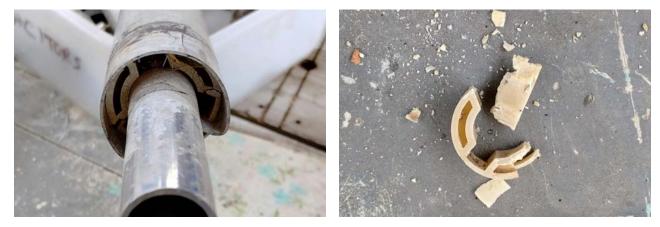
As soon as I removed the electrical tape that covered the protective plastic end caps on the traps I knew I had a problem. Now the person who I bought the antenna from had warned me the end caps would need to be replaced and had even supplied me with new caps he'd never got around to using.

But what I wasn't expecting was the condition of the plastic spacers that were used inside the traps.

After checking out a couple of web sites and watching a few videos (Google and YouTube are your friends), I decided to try 3D printing replacement spacers and after a little trial and error came up with a design that would do the job. I printed them in PLA and hoped that, since they're inside the aluminum tube, they wouldn't break down or melt. I'll find out next summer how that worked out.

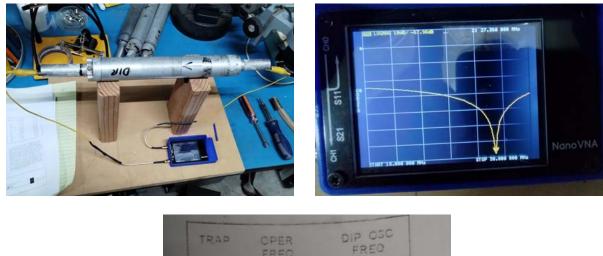
But before I replaced the crumbling spacers I made up a test jig and used my NanoVNA to test the traps. Using information I found online I was able to verify that the traps seemed to be working.

REQ 8.60 1.50	27.50 20.39
1.30	20 20 27 00
8.80	27.60
8.11	17.29
4.18	20.20 12.65
	8 00 8 60 4 90 8 11 1 30

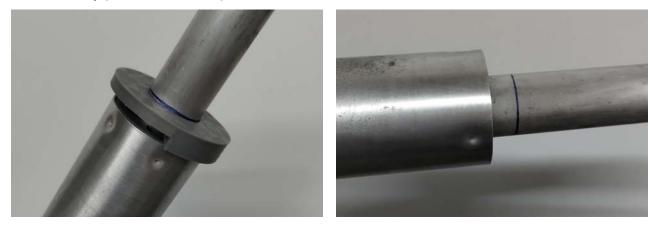
While I was 3D printing things, I designed and printed a little tool that allowed me to mark the assembly points on the traps.

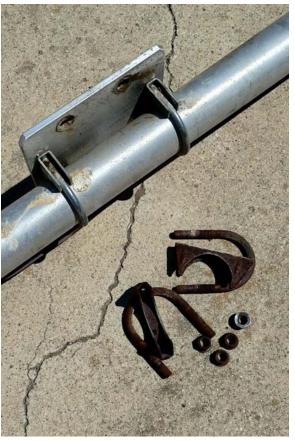
That out of the way, I lowered my tower and removed the Q52 and learned something. Just because someone says something is stainless steel, doesn't mean it is. As demonstrated by the rusted "stainless steel" U-bolts to the right.

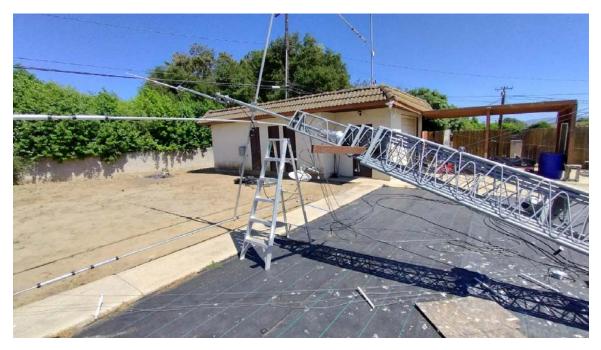
Old antenna and rotator removed and new antenna and rotator installed. Please note the red 2x4 that I installed because I had to extend the top section of the tower so I could install the new rotator. I didn't want anything to suddenly move while my hands were inside the tower tightening bolts.

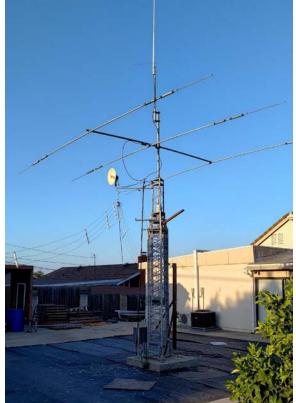
Now it was time to raise the tower and test my new antenna at height. Unfortunately I had forgotten to remove the red 2x4 before raising the tower to its vertical position and now there was too much weight resting on the 2x4 for me to remove it safely, so down came the tower again.

After removing the 2x4 the tower was returned to its upright condition and extended to its full height.
